## TALLINN AMM/SAM LAUNCH COMPLEX, USSR, CHANGES AND ADDITIONS

PHOTOGRAPHIC INTERPRETATION REPORT

## TALLINN AMM/SAM LAUNCH COMPLEX, USSR, CHANGES AND ADDITIONS,

AUGUST 1965

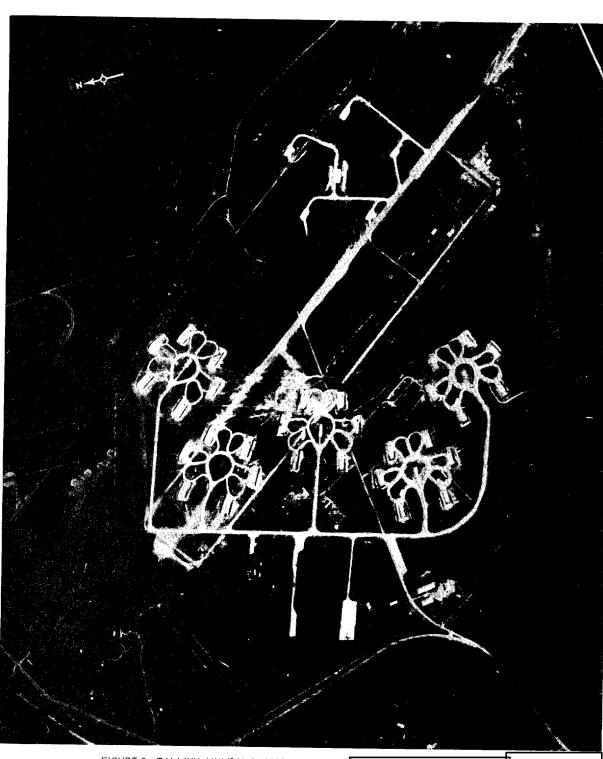
FIGURE 2. TALLINN AMM/SAM LAUNCH COMPLEX,

is under construction at 59-24-25N 24-19-30E, 13 nautical miles (nm) west-southwest of Tallinn (Figure 1). Its history and status of construction as revealed by photography through (Figure 2) were reported in a previous NPIC publication. 1/

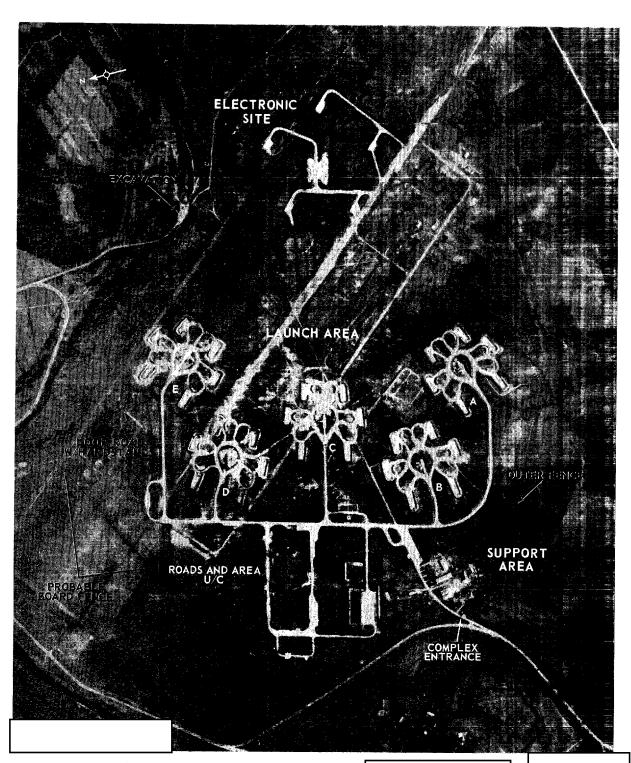
FIGURE 3. TALLINN AMM/SAM LAUNCH COMPLEX,

The complex was observed on very good quality, stereo, KH-7 photography of Figures 3, 5, 6, 7, 8, 9, 10, 11). This was the first snow-free coverage since and provides the best basis for an assessment of changes and additions since that date.

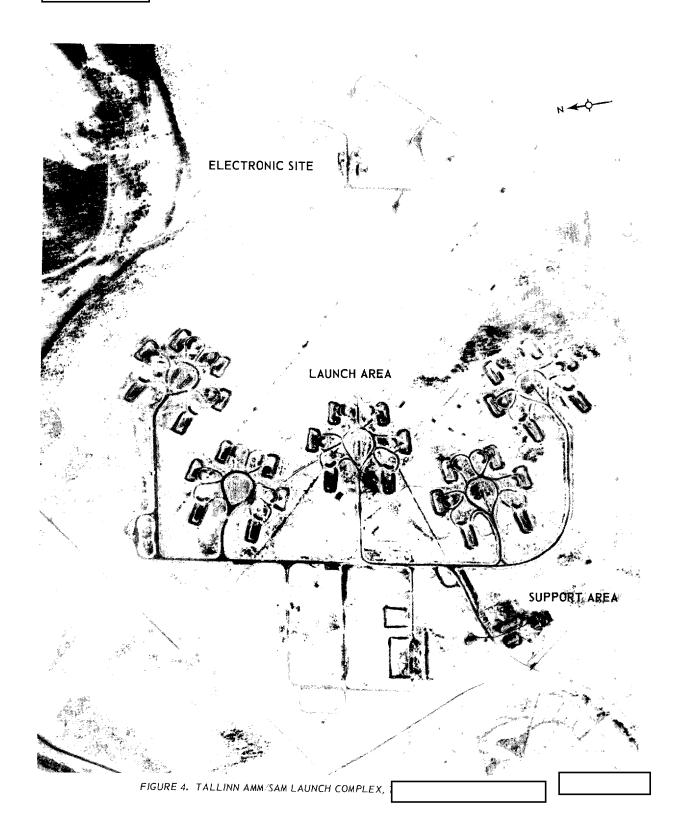
Considered chronologically, subsequent to the Tallinn complex was next observed on good-quality, nonstereo KH-7 photography of (Figure 4) with snow cover limiting interpretation. Significant changes and/or additions since observed on the photography include narrow V patterns in 5 of the 6 launch positions of Launch Site A and within each launch position within Site B; a van or structure occupying a new revetted position in the guidance/control areas of Sites A, B, and C; con-

struction of additional revetment walls at several launch positions; expansion of the road system and construction of revetted areas in the area west of the main road serving the Launch Area. A new revetted area was also constructed east of the Launch Area main road near its intersection with the access road to Site C. New

aprons were constructed along the main road and a new loop road with aprons was constructed on the northern side of the access road to Launch Site E. A new section of probable board fence, constructed since extends along the northwest boundary of the complex. Two new buildings were observed under construction in the Support Area near

The majority of graphics included in this report were selected from the snow-free, largescale photography of Many of the features shown as new on these graphics were present in (Figure 4) but none so annotated were present in In some instances snow cover may have concealed some of the features in The V patterns evident within the launch positions of Site C on were not discernible on the \_\_\_\_\_ photography and probably indicate construction progress. buildings under construction in the Support Area were in an earlier stage of construction Additional material was removed from the central area of the Electronic Site between

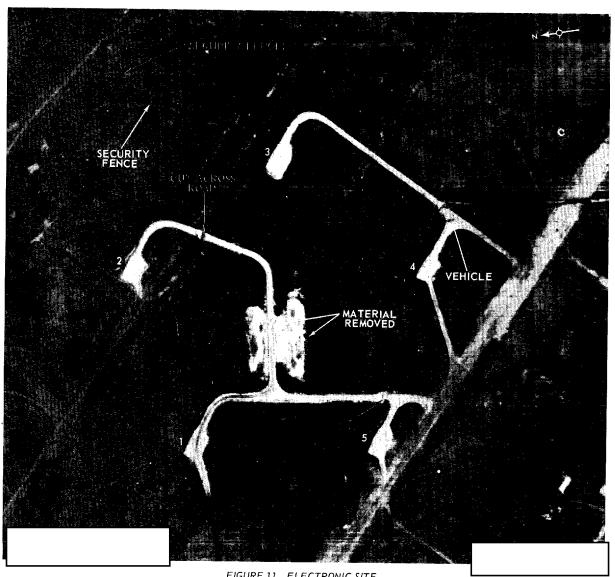
FIGURE 11. ELECTRONIC SITE.

the complex entrance. Some of the material used for construction of the revetment walls at the centrally located position within the Electronic Site was removed between
